LPS Bulletin – Reliability

RI-5 Rheniformer-Fire at E-570B 14-Oct-09

Location: Richmond – 5
Rheniformer

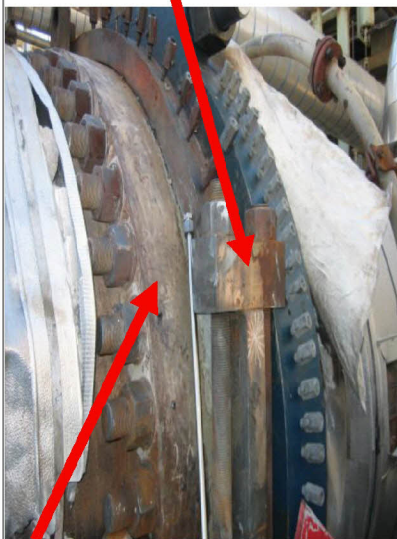
New Clamp: Tube sheet to
Shell

Old Clamp: Channel to
Tube sheet

While the plant operator was performing routine tasks, it was noted that there was a fire on E-570B, a feed/effluent heat exchanger, at the “Channel to Tube” sheet flange (See attached picture). The operator informed the Head Operator (HO) of the fire and applied smothering steam to the affected exchanger. The fire grew in scope and the operator applied water from a fire monitor to the affected exchanger. The CFD (Chevron Fire Department) quickly responded to the scene. The plant was shut down in a controlled manner.

1. These exchangers have leaked in the past and the situation has been addressed by clamps.
2. Threaded tubesheet design on this exchanger makes the connection much stiffer as it reduces the amount of available stretch in the stud that can compensate for some of the relaxation of the gasket.
3. The tubesheet is threaded on the channel side, so the amount of stud stretch on the channel side is less than the stretch on the shell side.
4. The clamp that was in place on exchanger leaked.

1. New/ Enhanced Engineering Design is an important tool in preventing future incidents/ hazards such as this.
2. Given that these exchangers are known leakers, changes are already in place and a more reliable gasket (enhanced design with different geometry and rated for higher loads/temperatures) will be installed and a new style bolting pattern used.
3. Higher tension is needed to prevent leaks due to gasket relaxation on exchangers.
4. Generally, clamps may be used to stop leaks when the equipment cannot be shutdown, and refinery instructions require removal of clamps and equipment repair during planned shutdowns.

1. Determine what other exchangers in the refinery are at risk to this same problem.
2. Install new, more reliable gasket on all flanges (enhanced design with different geometry and rated for higher loads/temperatures) and use new style bolting pattern on this exchanger and others in same service/process to ensure proper tension on gasket.
